# Lake Monomonac | Watershed Survey Results

**TO:** Don Wilson and Midge Romanow, MLPOA  
**FROM:** Grace Little, FB Environmental Associates (FBE)  
**SUBJECT:** Lake Monomonac Watershed Survey Results  
**DATE:** February 20, 2026  
**CC:** Laura Diemer, Tim Kirsten, & Amelia Wallis, FB Environmental Associates

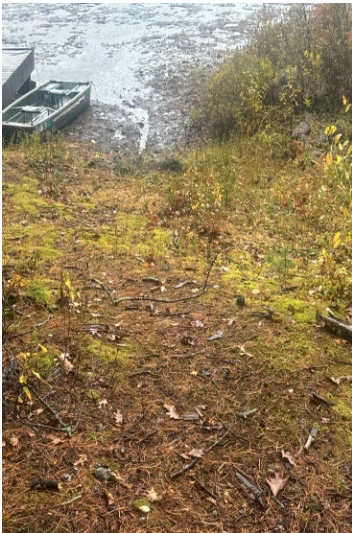
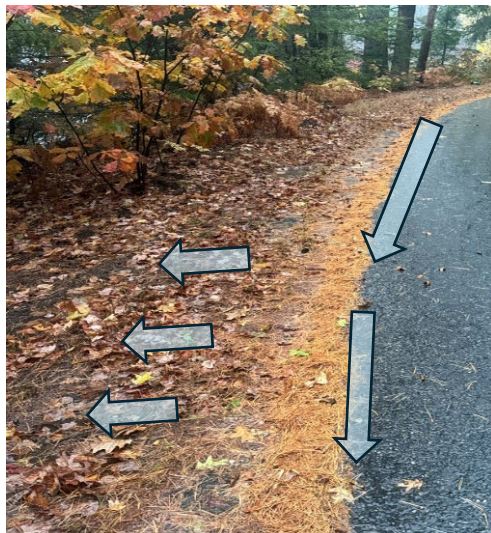
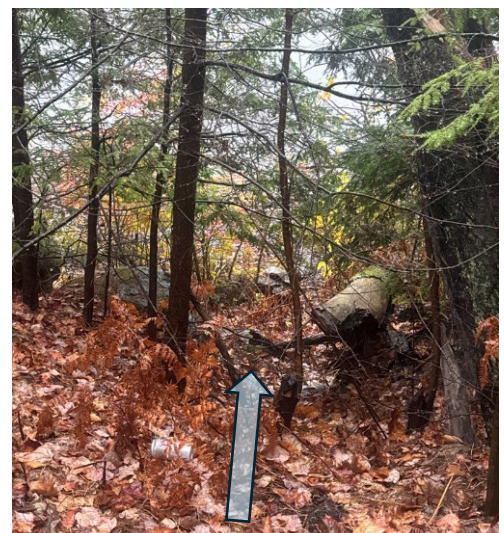
### Site M-1: West Monomonac Road

**Observations:** The shoreland riparian buffer between 85 West Monomonac Road and Lake Monomonac is very narrow. Two minor gullies have formed in this area, although the shoulder is reasonably well-vegetated and likely slows some of the runoff entering the lake at this location. There is however a break in the shoreline buffer where vegetation cover is lower; this area appears to be a path leading from the road to a private dock on the lake. There is an unpaved driveway uphill of this site (on the east side of the road), which is a possible sediment source to this site. West Monomonac Road is a town owned road of Winchendon, MA.

*A break in shoreline vegetation that likely receives moderate foot traffic, providing access to a private dock (left). Runoff from West Monomonac road drains to the lake through the narrow shoreline buffer, as indicated by the blue arrows (middle). Small channels (obscured by leaves in this photo) lead from the road shoulder to the lake through the vegetated buffer (right).*

**Recommendations:** Continue engaging shoreline property owners to maintain adequate shoreline buffers that include a variety of native shrubs, trees, and herbs. Where lake access is desired, encourage private landowners to add some level of stormwater treatment at the base of the access path, or to create turnouts into more vegetated areas. If the area is used as a path to the water, consider installing infiltration steps and/or a meandering access pathway that minimizes erosion to the lake. Provide technical assistance to shoreline property owners so they are aware of these stormwater management options, why it is important to reduce sedimentation into the lake, and the permits that would be required to work in the shoreland zone.

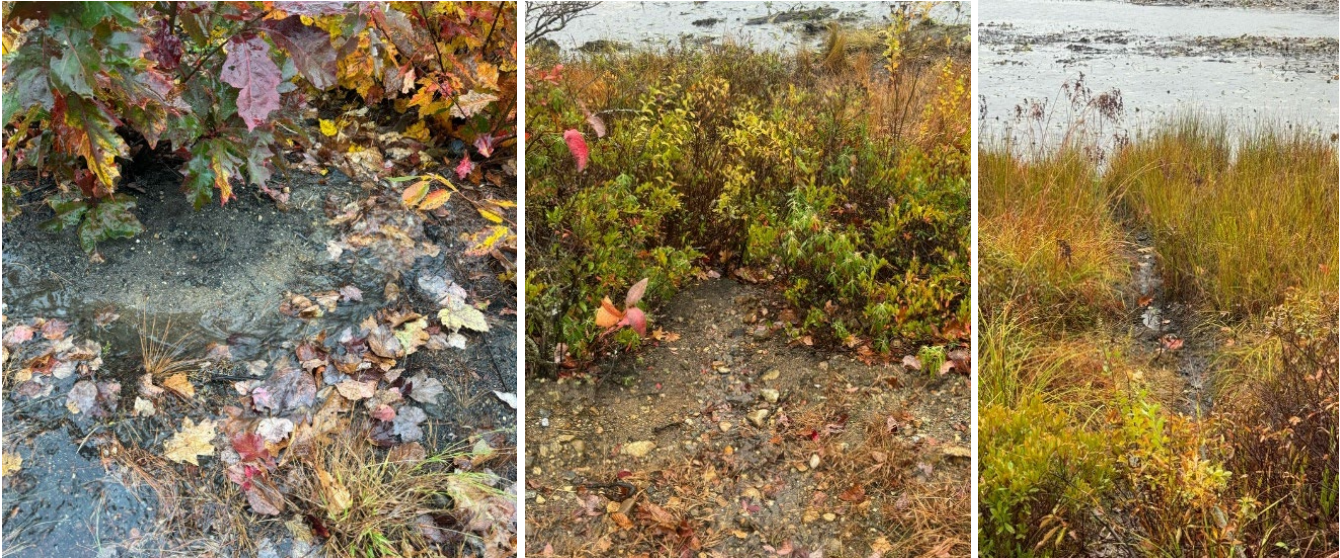
## Site M-2: Bridge on Island Road

**Observations:** Island Road is the only road located on Blueberry Island, connected to West Monomonac Road by a narrow causeway/bridge. There are at least eight short gullies that lead from the roadside ditches directly down to the lake on both sides of the road. Island Road is a privately owned and maintained road. o

*Visible sediment transport (left) directly adjacent to the lake (middle). A channel at the end of an erosion gully extends through the wetland on the west side of Island Road (right).*

**Recommendations:** We recommend installing riprap and live stakes in the gullies, particularly on the western side of the road. Live stakes can either be installed vertically through the riprap or placed horizontally beneath the riprap. Native shrubs that can be used for live stakes include dogwoods, willows, buttonbush, elderberries, and white meadowsweet.

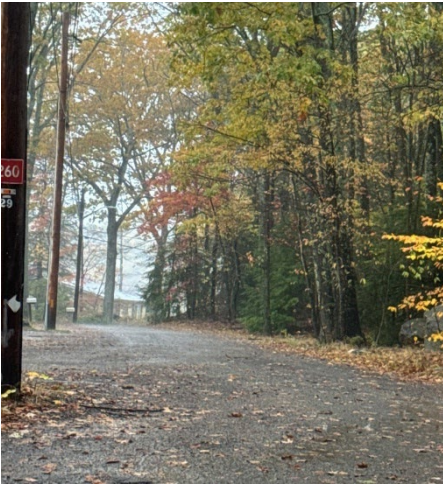
### Site M-3: Second Street

**Observations:** Second Street is an unpaved road off West Monomonac Road with several gullies leading through private properties to the lake. Multiple properties have inadequate shoreline buffers (large lawns with no trees), and several gravel driveways provide sediment transport from Second Street to the lake. This area is relatively flat, which limits the formation of deeply incised gullies. Second Street is a town owned road of Winchendon, MA.

*A view of the unpaved Second Street. Most of the area is privately owned.*

**Recommendations:** We recommend Winchendon DPW investigates options to pave or recrown the road. Refer to the general road BMPs recommended at the top of this memo. Encourage property owners to enhance their shoreline buffers by planting more shrubs and trees, and to install cost-effective stormwater BMPs on their properties to capture and treat stormwater runoff.

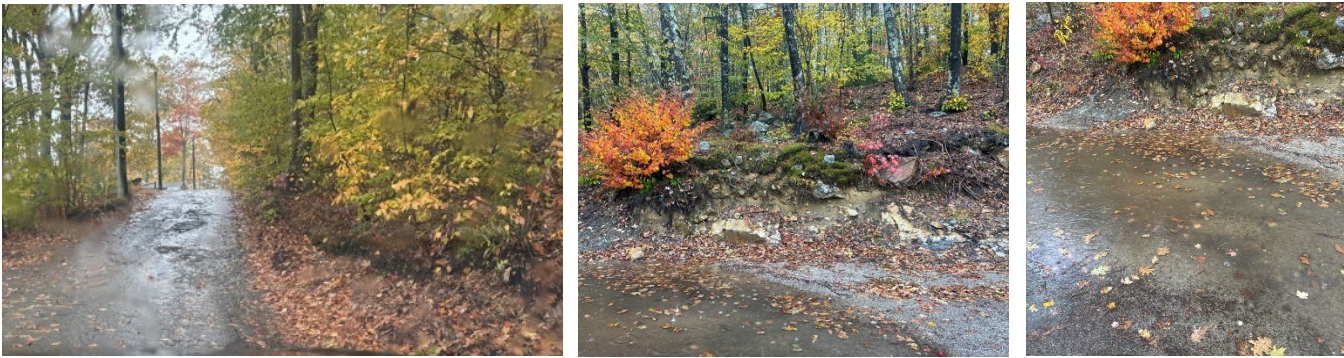
## Site M-4: Fourth Street

**Observations:** The whole gravel road is eroding in places and the slope from the road down to the lake is steep. There are several gullies between houses and down gravel driveways leading straight to the lake. There is also a parking area with unvegetated, steep slopes. Water is also pooling in sections of the road. Most of the land here is privately owned. Fourth street is a privately owned and maintained road.

*Gullies along the center of the Fourth Street (left) contribute to bank erosion beside the road (middle). Water pools downstream from the eroding roadway and directly below the unstable bank (right).*

**Recommendations:** Repair or rebuild the road to prevent the large scale erosion currently occurring. Refer to the top of this memo for general unpaved road BMPs; pooling water indicates the road may need to be regraded to superelevate or crown the surface. Through public education and outreach, seek opportunities for rain gardens and infiltration basins between houses. Encourage enhanced vegetation on shoreline properties. Vegetate the base of the steep parking area to capture sediment. The road traverses both Winchendon and Rindge, so work with both Towns to improve stormwater management along this road.

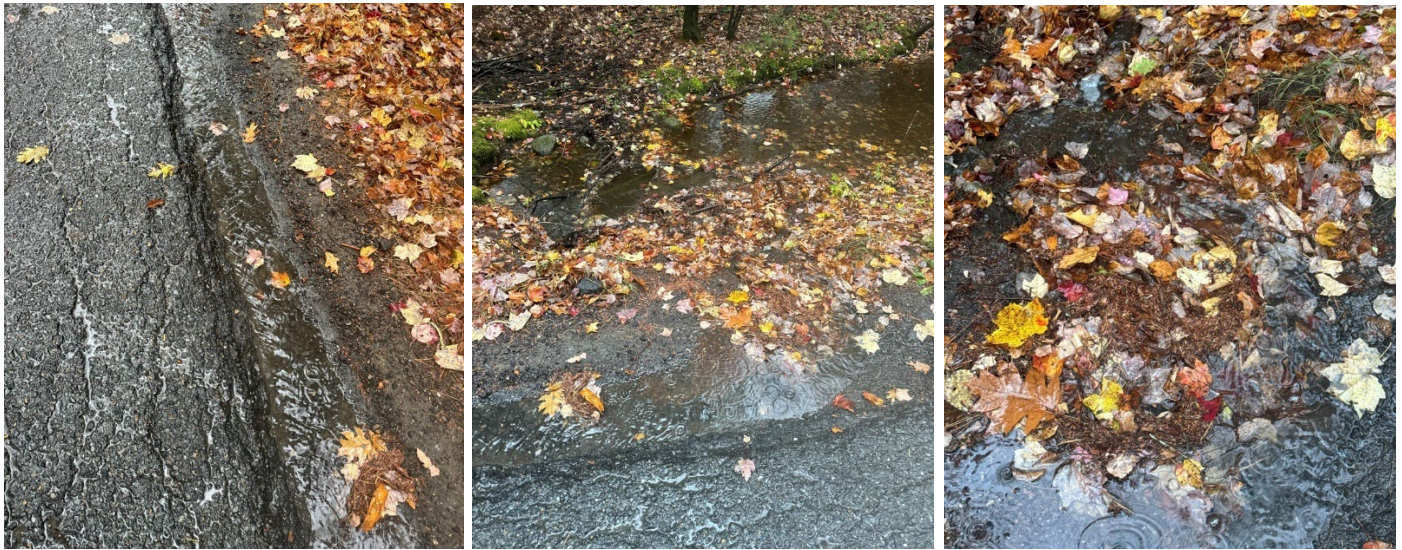
## Site M-5: East Monomonac Road

**Observations:** A small road shoulder gully runs from 255 East Monomonac Road to a stream crossing that discharges to the lake approximately 200 feet downstream. Some pooling of water was observed on the shoulder. The final part of the gully is a narrow ditch/gutter. The crossing is just south of the MA/NH border. East Monomonac Road is a town owned road of Winchendon, MA.

*Small roadside gully that transitions into a gutter (left), leading to a pool of water (middle) filled with plant debris (right) that drains into the stream crossing.*

**Recommendations:** Install riprap in the final part of the gully to capture sediment before it reaches the stream crossing.

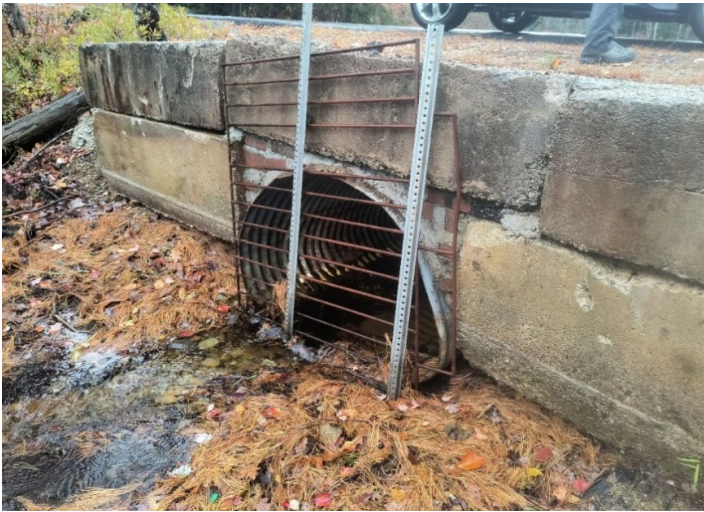
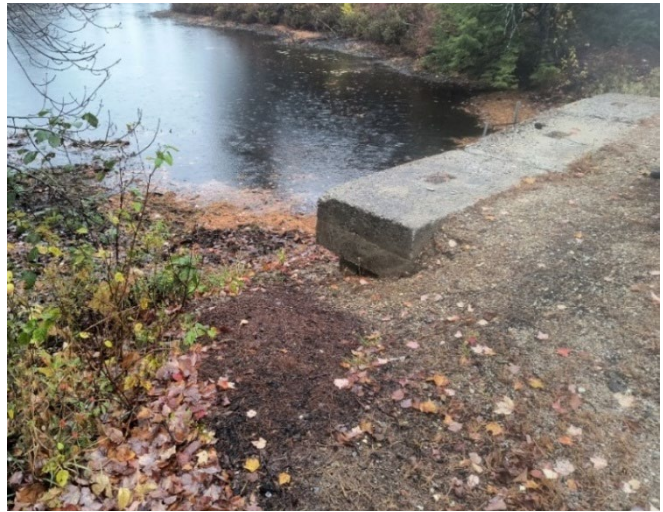
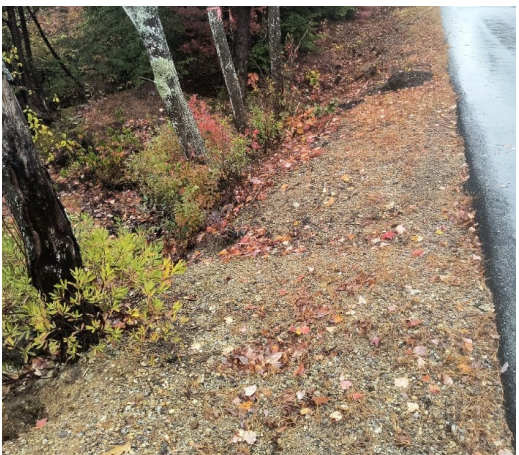
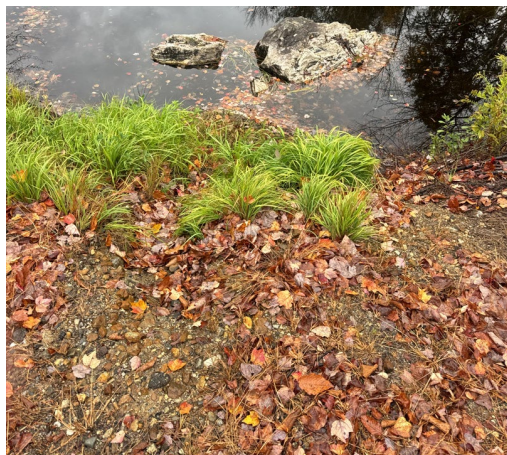
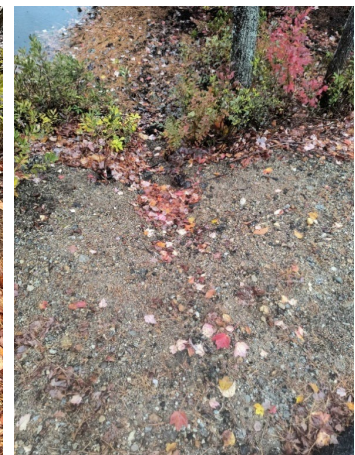
## Site M-6: 376 East Monomonac Road Culvert

**Observations:** A large corrugated metal pipe connects Lake Monomonac to a backwater pond/scrub-shrub emergent wetland on the east side of East Monomonac Road. According to Rindge DPW director, Cloutier, this culvert was replaced recently. The culvert is treated to prevent rust and has a metal grate on both ends that requires regular debris clearing maintenance. This area has experienced beaver activity in the past. The road shoulder is unvegetated above the headwalls at both the inlet and outlet. This has caused four short gullies to form, one on each side of each headwall. Both the inlet and outlet require some level of access for maintenance of the grates. East Monomonac Road is a town operated road of Rindge, NH.

*A metal grate over the culvert outlet (top right), and a view of the unvegetated shoulder above the culvert outlet's headwall (top left). Gullies in the road shoulder in the vicinity of the culvert (bottom left and right). Sedges on the bank above the culvert inlet (bottom middle).*

**Recommendations:** Install riprap in the gullies to stabilize the soil surface. Plant herbaceous vegetation in the narrow strip of road shoulder between the road and the culvert headwalls, as there is limited space for shrub plantings. Plantings should use seed only. Do not apply fertilizer, compost, or mulch, and avoid any soil disturbance, as these activities could impact the lake. Enhance the herbaceous plant layer on the inlet side by planting more sedges in the gaps between those already established on this bank. Regularly maintain the riprap to ensure it does not get dislodged when accessing the metal grates over the inlet and outlet.

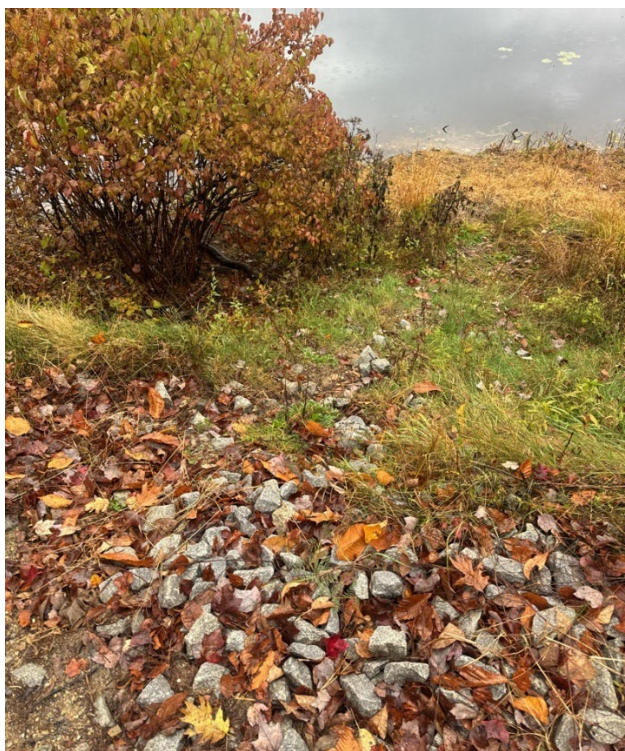
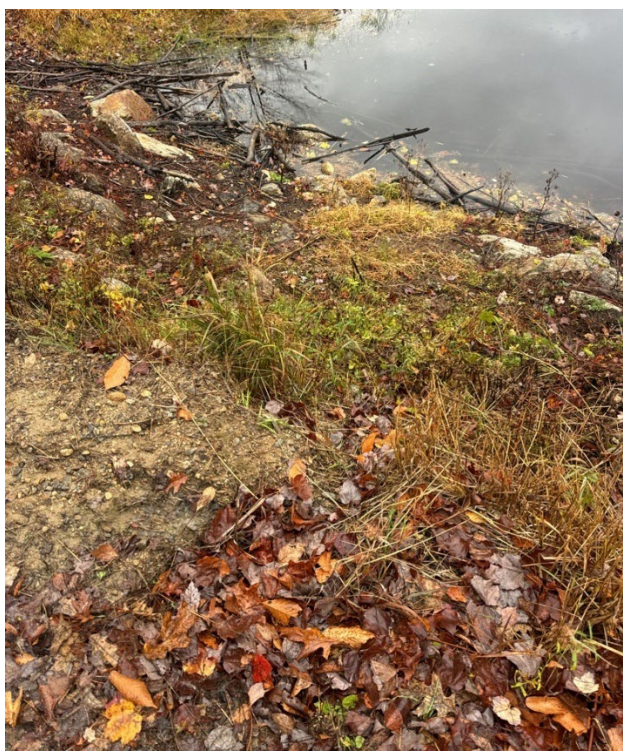
## Site M-8: Bancroft Road Crossing

**Observations:** Bancroft Road is an unpaved, sandy road in the northwestern portion of the watershed. A culvert conveys the outlet stream of Bancroft Reservoir beneath the road. The stream ultimately discharges into Converse Meadow Pond and then into Lake Monomonac, roughly 2 miles downstream of the reservoir. The road shoulder slopes steeply (> 10%) from the road to the Bancroft Reservoir, and a section of riprap has washed out from the shoulder down the slope. This has exposed a patch of unvegetated soil where fast-flowing runoff can transport sediment to the waterbody. Sediment is transported from the surface of the unpaved Bancroft Road. Bancroft Road is a town owned road of Rindge, NH.

*Small erosion gully leading to Bancroft Reservoir, with riprap washed out and leading towards the lake (left). Exposed sediment and sand from the road, leading towards to the reservoir in a section with minimal vegetative buffer (right).*

**Recommendations:** Re-install riprap and revegetate exposed, unstable slopes near the Bancroft Road crossing. Live stakes may be an ideal low-cost option here given the steepness of the slope. Consider using native New England place species including native dogwood, willow, elderberry, and buttonbush. These plants have well-established roots and will stabilize the soil below the riprap and reduce the likelihood of future riprap washouts.

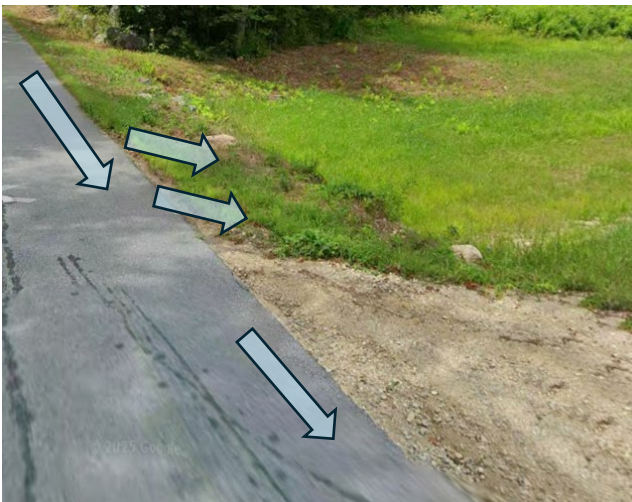
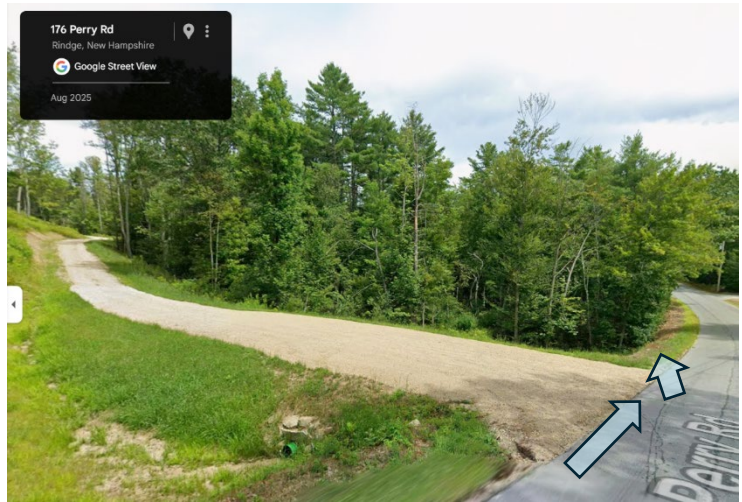
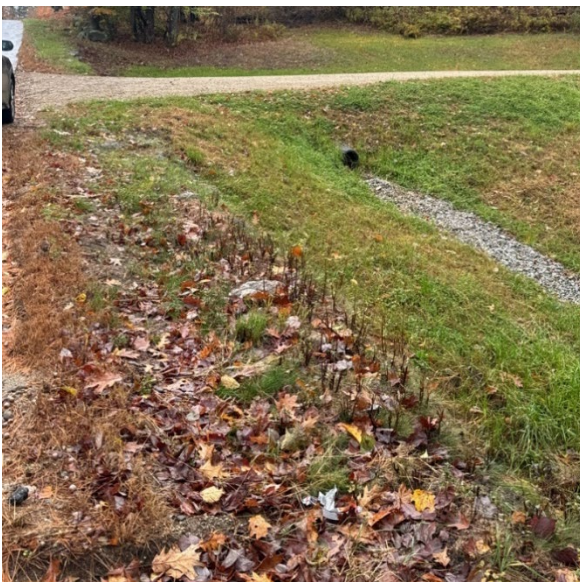
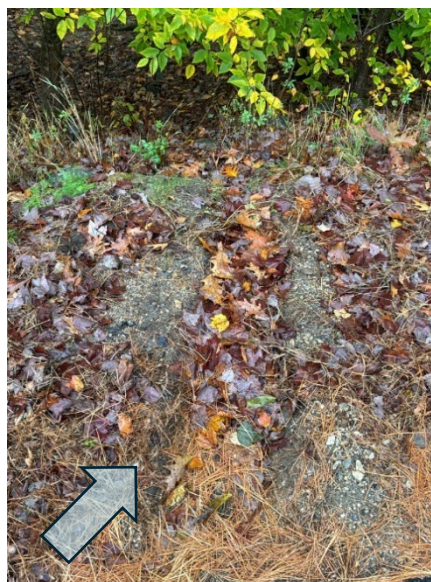
## Site M-9: Perry Road

**Observations:** A narrow road shoulder gully has formed above the gravel driveway of 176 Perry Road. While most of this drains to a formal ditch and then a cross-driveway culvert, some runoff continues flowing across the driveway, which is beginning to erode. This runoff then discharges into a wooded, low-elevation area on the south side of Perry Road. It was unclear if this wooded area connects to a stream or wetland, or if it is an isolated depression. The cross-driveway culvert which transports the bulk of runoff from this site has a well-riprapped outlet that slows water movement. Perry Road is a town owned road of Rindge, NH.

*Runoff flows down the shoulder above the driveway, where there is some erosion, and either flows into the grass-lined ditch or crosses the driveway (top left). Runoff that bypasses the ditch flows across the driveway and into the wooded depression (top right). A view of the riprapped driveway culvert outlet and of minor shoulder erosion below the driveway (bottom left). Scour and exposed soil caused by Perry Road runoff in the wooded depression (bottom right). Blue arrows indicate dominant direction of runoff flow. Top photos are taken from Google Street View imagery dated August 2025.*

**Recommendations:** Install small-sized riprap along the road shoulder in sections that are eroding, including near the base of the depression downslope of 176 Perry Rd. Enhance native vegetation in this area. If it is too steep for regular plantings, utilize live stakes.

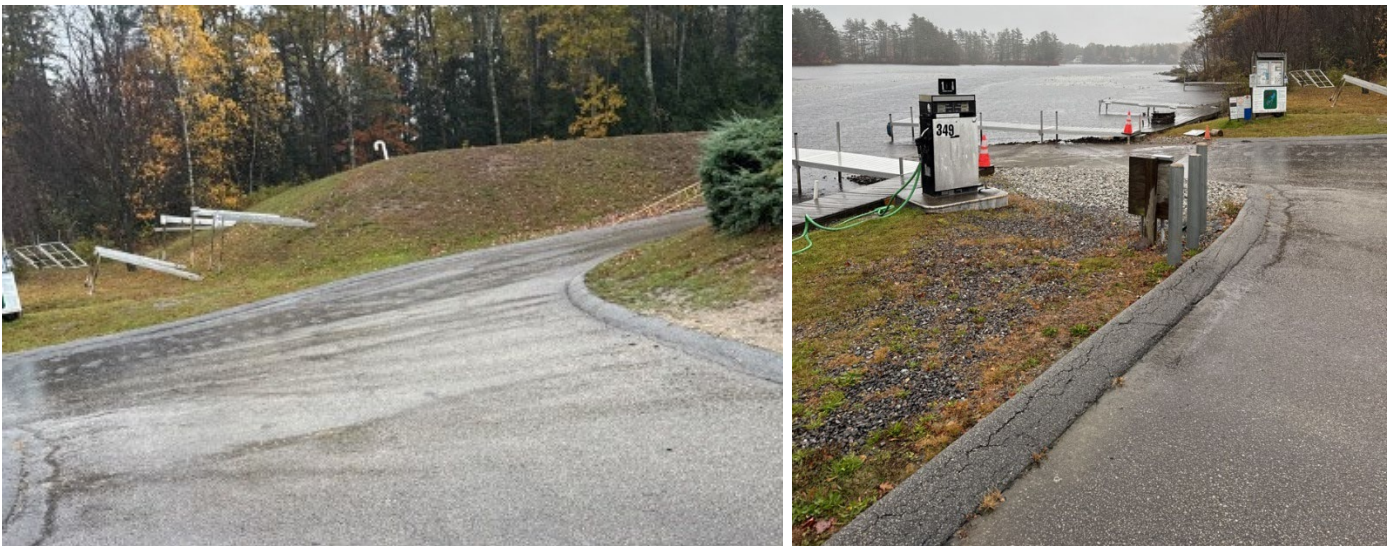
## Site B-1: Boat Launch

**Observations:** A boat launch located on the western shore is privately owned by the "North of the Border Food Mart," located along New Hampshire Route 202 in Rindge. The road leading down the boat launch channels upstream stormwater from the gas station and Route 202 directly into the lake. There are no turn offs or catch basins, and paved curbs direct all stormwater into the lake with no vegetated buffer to treat stormwater or opportunity for infiltration. The project group also observed that wind frequently blows trash from the Mart's trash bins onto the banks of Monomonac Lake, where it can enter nearby waterways.

*Visible runoff flows down the impervious surface of a paved road, draining from a nearby gas station and major roadway directly toward the lake (left). The asphalt road transitions directly into the boat ramp with no vegetated buffer along the sides (right). Paved curbs channel runoff from the surrounding impervious surfaces straight into the lake (both images).*

**Recommendations:** Add check dams along the driveway that divert water into a vegetated swale. Add gravel or porous pavement to the area closest to the boat launch and as much of the driveway as possible. Install a vegetated buffer along the shoreline. Consider trash management strategies to avoid trash from getting blown from trash bins to the water banks. Discuss with private Mart owner on moving bins farther from shoreline or find wind-resistant lids (weighted lids).

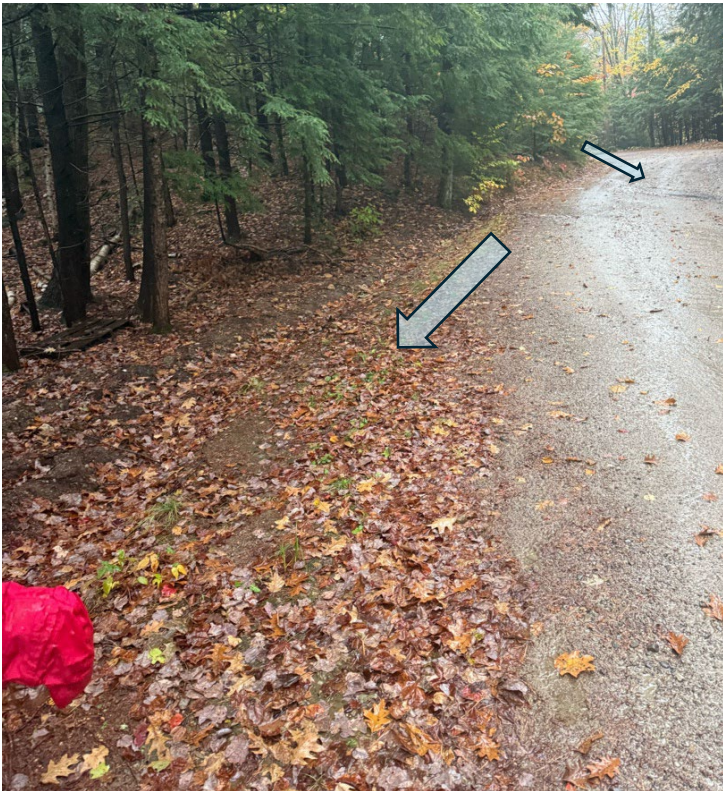
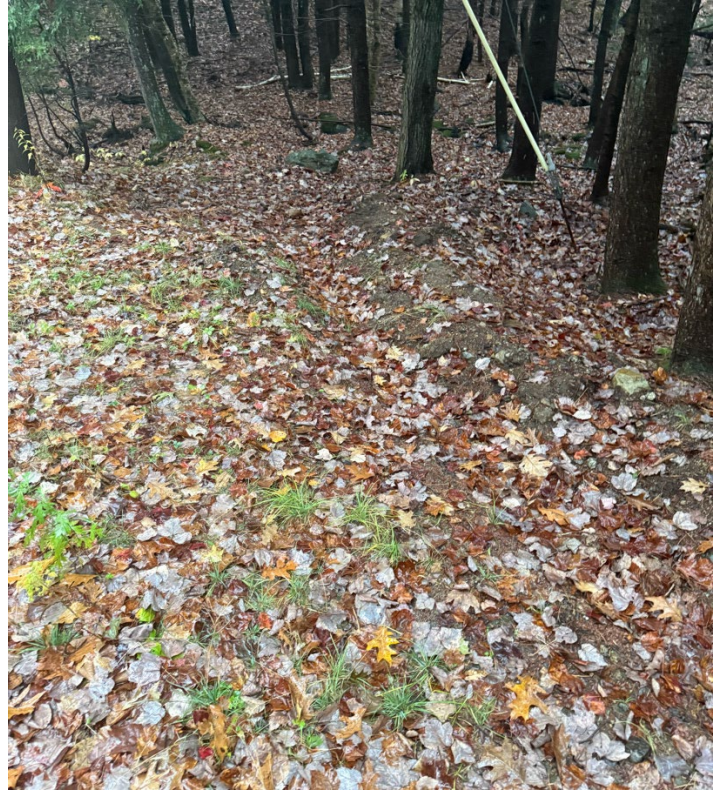
## Site B-2: Dolly Lane

**Observations:** An erosion gully has formed alongside Dolly Lane, which flows directly into a stream bed that outlets to Lake Monomonac. Some of water upstream of the gully runs across the dirt road and towards the lake, though there is more vegetation here to buffer that input. Dolly Lane is a privately owned and operated road.

*Facing uphill of Dolly Lane, a roadside gully has formed, with some smaller erosion gullies at the top of the hill running across the gravel road and towards the lake (left). The roadside gully discharges directly into a stream channel, which is shown at the top of the photo on the right.*

**Recommendations:** Install check dams along the road that outlet into the forest before water reaches the stream channel. Add a plunge pool at the base of the gully. Consider re-grading the road at the top of the hill to direct runoff into the check dams and plunge pool on left hand side and prevent sediment erosion.

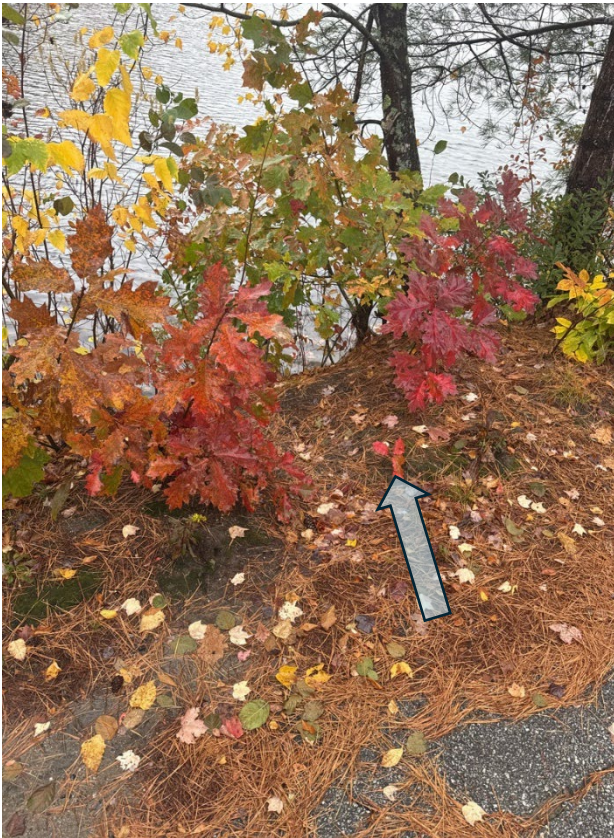
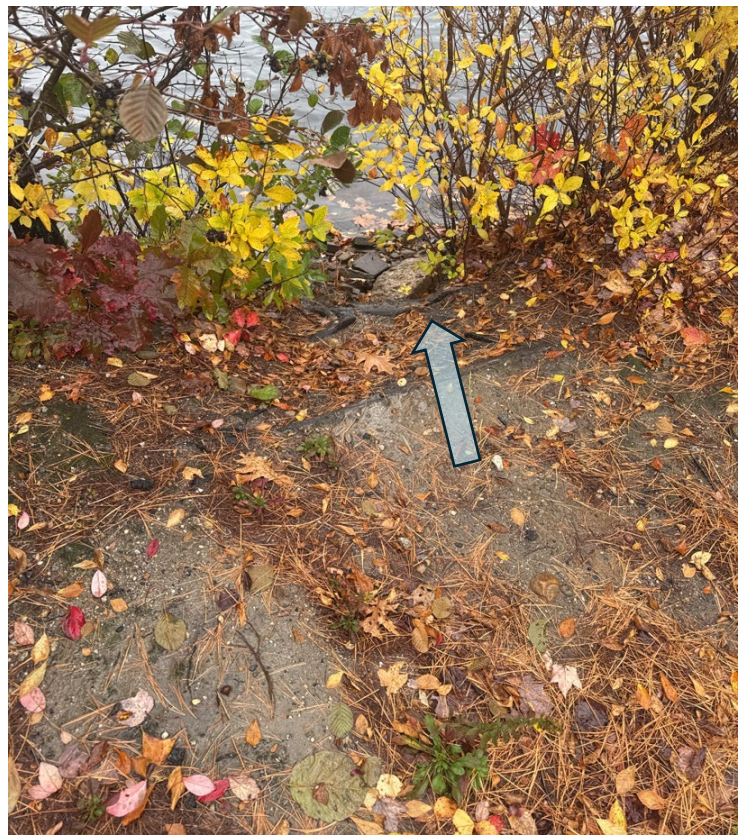
## Site B-4: Paradise Island Road Shorefront

**Observations:** The section of Paradise Island Road that spans the lake via a bridge has fourteen (14) small erosion ditches that pour directly into the lake. While the road shoulder is well vegetated considering the limited area of land, ditches have formed in-between shrubs, exposing roots and directing road-side sediment and stormwater directly into the lake.

*Small erosion gullies along the roadside, cutting through established vegetation, transport sediment and debris from the road shoulder into the lake.*

**Recommendations:** Re-establish vegetation at each gully site. Use live-stakes with native shrub species to ensure the roots are well established and to support bank stabilization. Consider armoring selected points along the shoreline with rocks to slow the rate shoreline erosion, though avoid adding sediment as much as possible. Shrubs native to New England that can be used for live stakes include native dogwoods, willows, buttonbush, elderberries, and white meadowsweet.

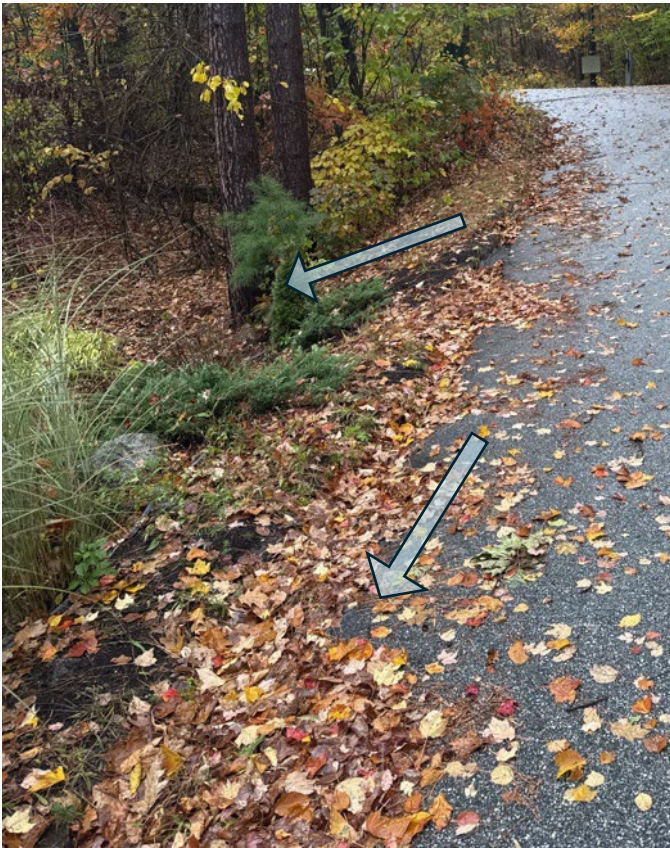
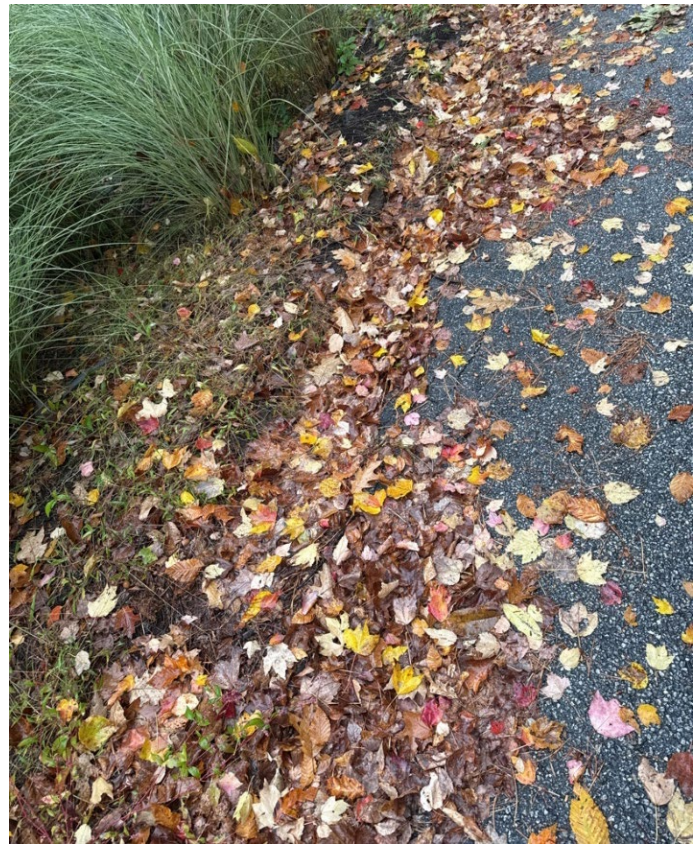
## Site B-5: Paradise Island Road Hill

**Observations:** A steep portion of Paradise Island Road, just before crossing over the lake, has formed a roadside gully which flows down to the lake. A few perpendicular gullies have formed, acting like turnouts, to bring the stormwater into a residential lawn. However, the majority of the gullies lead to a driveway catch basin which outlets directly into the lake. The lower section of Paradise Island Road where this site is located is privately owned. However, shortly uphill from the site the road is owned and maintained by the town of Rindge, NH.

*Roadside ditch erosion with some gullies draining into private property (left) and others directing flow into a catch basin that discharges directly to the lake.*

**Recommendations:** Vegetate or riprap the gully, and work with the property owner on establishing vegetation on their property to form a buffer where some of the stormwater is entering their property. Install an infiltration basin at the outlet of the catch basin and ensure the shoreline is properly vegetated.

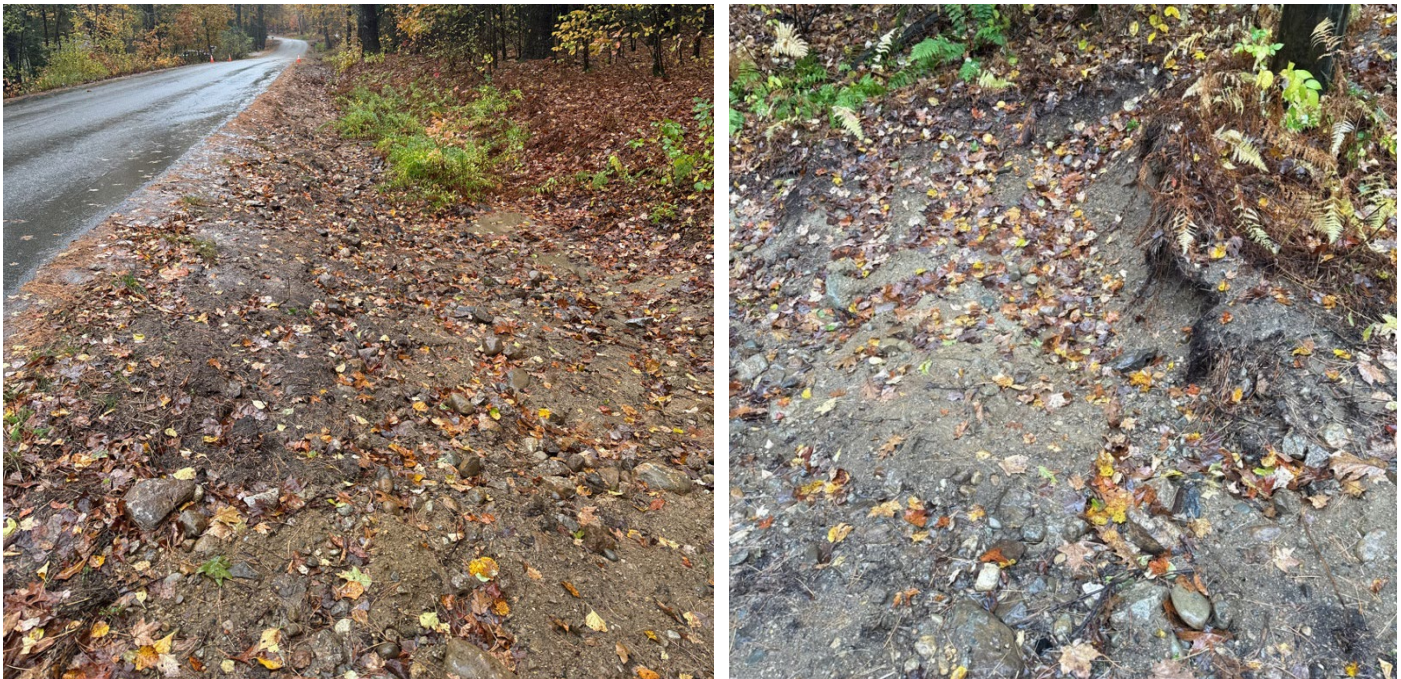
## Site B-6: Hubbard Hill Road

**Observations:** There is a large area of exposed soil along the road ditch on Hubbard Hill Road near the entrance to Kingfisher Terrace. While no signs of construction were noted during the survey, the absence of established vegetation upstream suggests recent disturbance. Erosion gullies have developed in the exposed soils within the road ditch, which drains to a culvert. At the lower half of the road ditch, established vegetation with no significant gullies indicates that re-vegetation upstream should be feasible. A large bank erosion was observed underneath a telephone pole, indicating the area is unstable and susceptible to erosion under large precipitation events or high-flow conditions. Hubbard Hill Road is owned by the town of Rindge, NH, while Kingfisher Terrace is privately owned and maintained.

*Exposed sediment along the road shoulder with visible erosion gullies (left), and an unstable sediment bank eroded by high-flow conditions (right).*

**Recommendations:** Establish vegetation across all areas of exposed soil, using live stakes to enhance slope stabilization, especially where bank erosion is occurring. Native shrubs that can be used for live stakes include dogwoods, willows, buttonbush, elderberries, and white meadowsweet. Riprap can be used if vegetation is insufficient. Consider planting larger trees in the exposed area near Kingfisher Terrace (uphill) where the lower grade and reduced flow provide favorable conditions for tree establishment, though be mindful of the telephone pole.

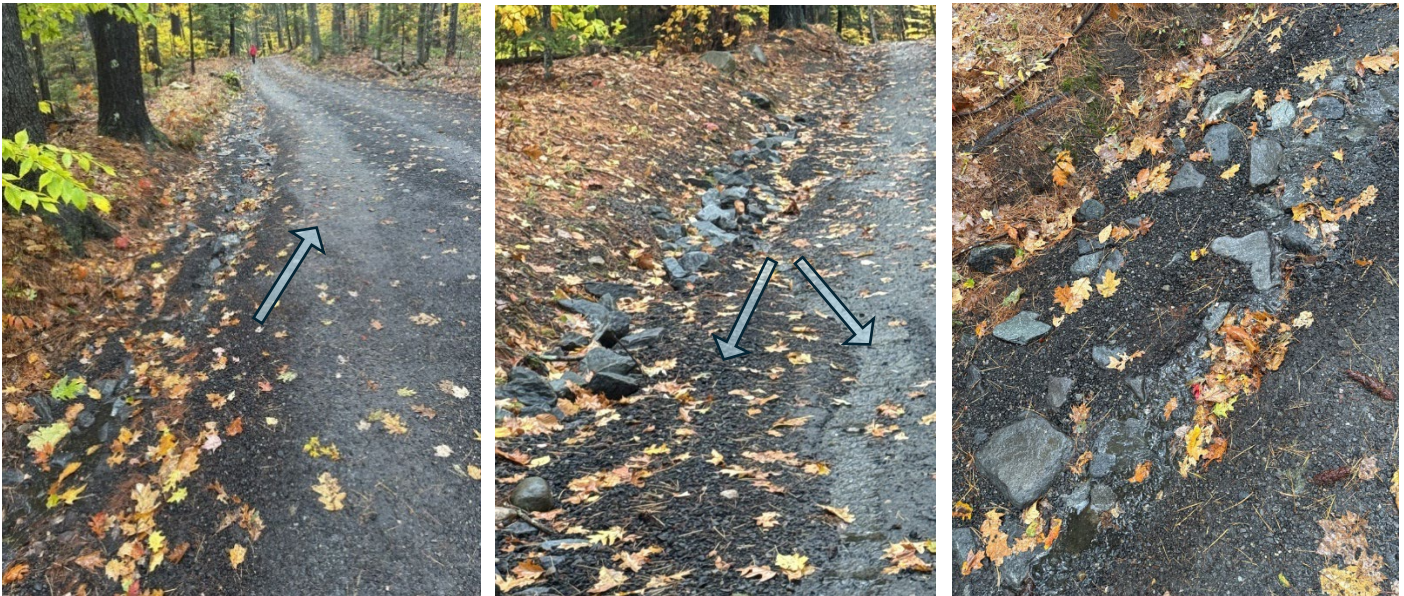
## Site B-8: Colburn Lane Hill

**Observations:** Several erosion gullies are present along the moderately sloped dirt section of Colbert Lane, which drains downhill toward the lake. Riprap from prior road construction is visible but has become partially filled with sediment, and some runoff now flows over the road instead of through the roadside ditch. Although the slope levels out before reaching the lake, reducing immediate transport of sediment into the lake, stormwater management issues are evident and should be addressed given the proximity of the road to the lakeshore. Colburn hill is privately owned and maintained.

*Erosion gullies formed in the road ditch and across the dirt road (left and middle). Road gravel is visibly washed into the ditch (right).*

**Recommendations:** Remove sediment from the riprap and perform regular maintenance. Regrade the road to ensure runoff drains into the side ditch rather than along the road surface. Install check dams and turnouts to redirect flow into the woods.

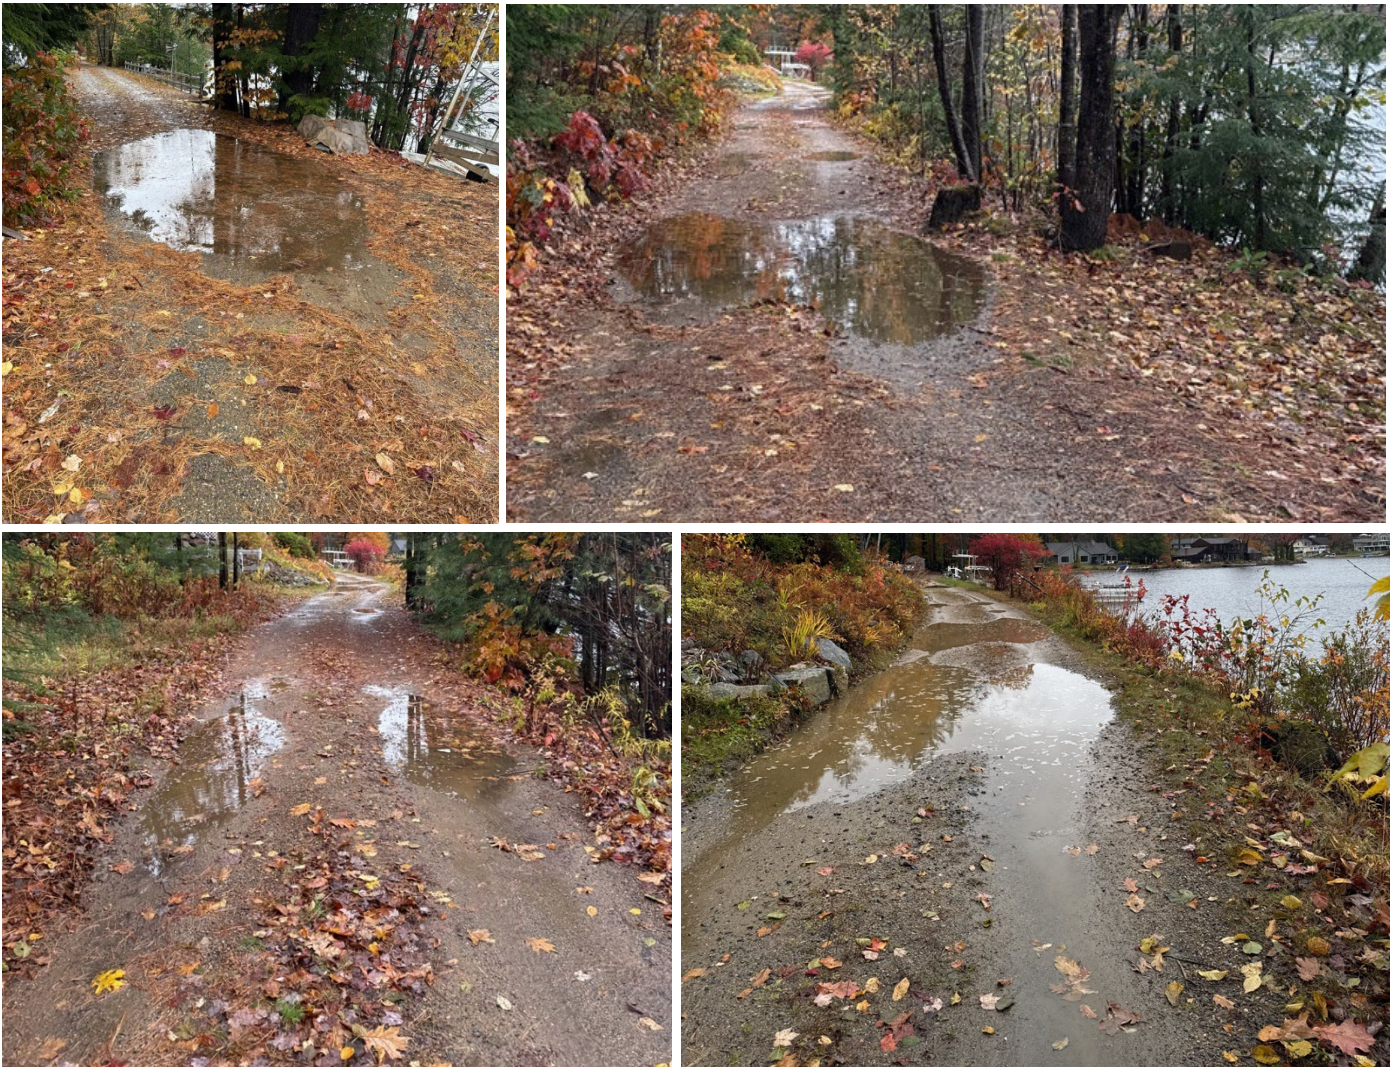
## Site B-9: Colburn Lane Shorefront

**Observations:** Colburn Lane runs very close to the lake shore, and has been previously flagged for having erosion issues. No gullies leading to the lake were observed here, though obvious drainage issues are present.

Drainage issues and pooling on the road, directly adjacent to the lake. Vegetated buffer to the lake could be improved in places (bottom right).

**Recommendations:** Improve vegetated buffer between the road and the lake in some areas. Educate property owners on proper stormwater management. Conduct regular road maintenance to ensure no erosion issues arise during large storms. Consider adding woven geotextiles under surface materials to reduce pooling issues. Consider plastic-free woven geotextiles, for example coconut fiber. Consider enforcing beach laws in this area, as some properties may have imported sand on moderately sloped shoreline areas. Artificial sandy beaches are unsustainable because the sand will wash away or settle into the lake, accelerating lake aging and harming aquatic ecosystems by smothering organisms, disrupting food webs, damaging fish habitat, and increasing plant growth as the lake becomes shallower.

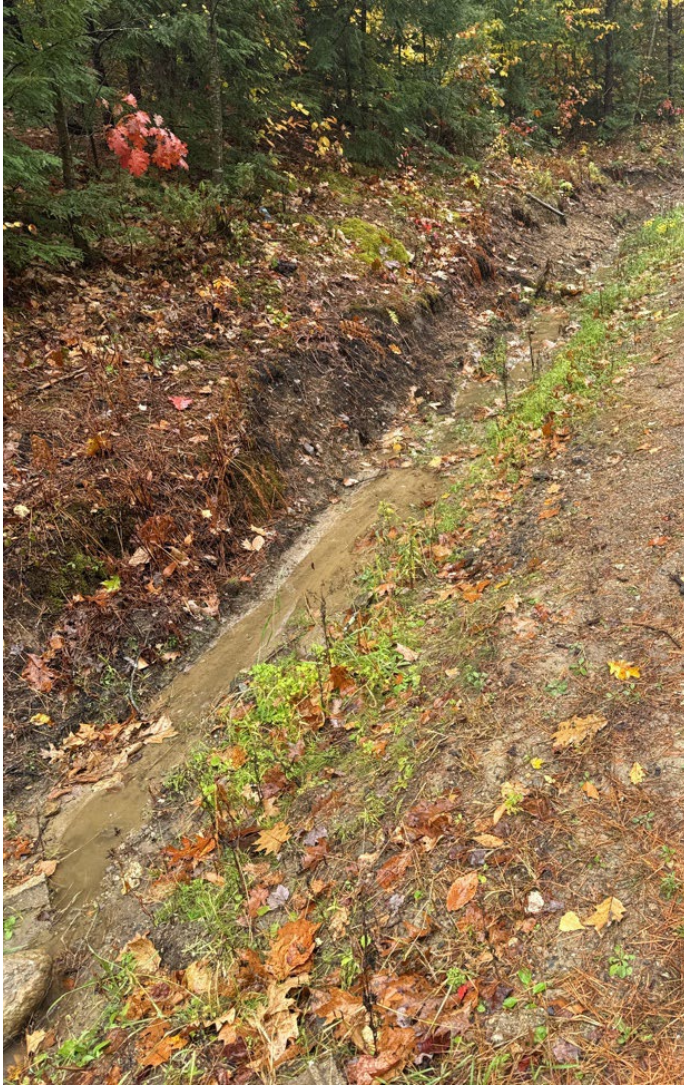
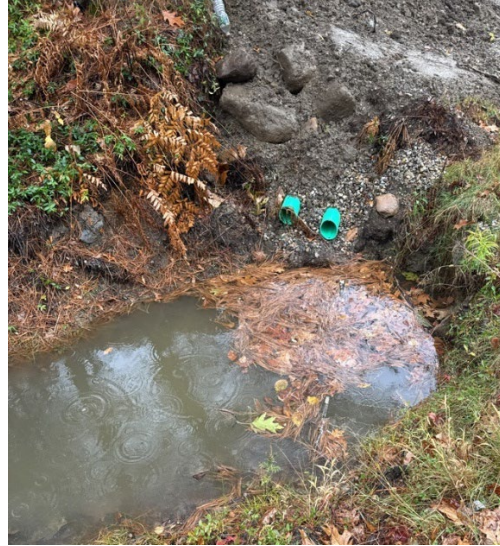
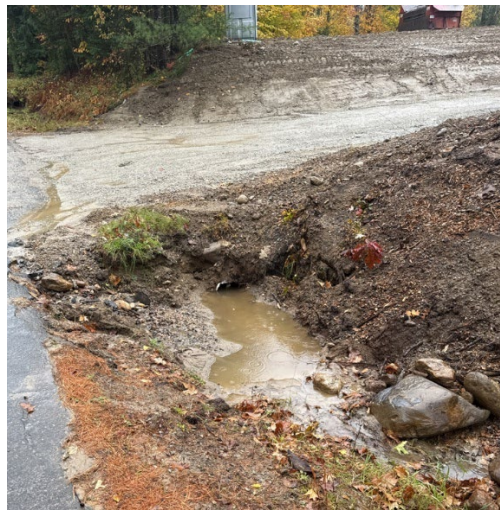
## Site B-10: Swan Point Road

**Observations:** A road-side ditch gully filled with sediment-laden water and visible bank erosion. Two pipes from a residential property outlet into the ditch. A crushed culvert is causing water to back up, increases bank erosion, and prevents proper drainage. Large portions of exposed sediment are present in the abutting property, which is currently under construction with minimal sediment control measures. Swan Point Road is a town owned road of Rindge, NH.

*Eroding road side ditch (left). Pipes from residential property leading to clogged culvert that is backed-up and causing bank erosion (top right). The crushed culvert is visible downstream of the pool, with additional pooling, erosion, and exposed sediment (bottom right).*

**Recommendations:** Riprap and vegetate the road ditch. Replace and upsize the culvert and educate property owners on upstream stormwater practices. Investigate the use of the private pipe.

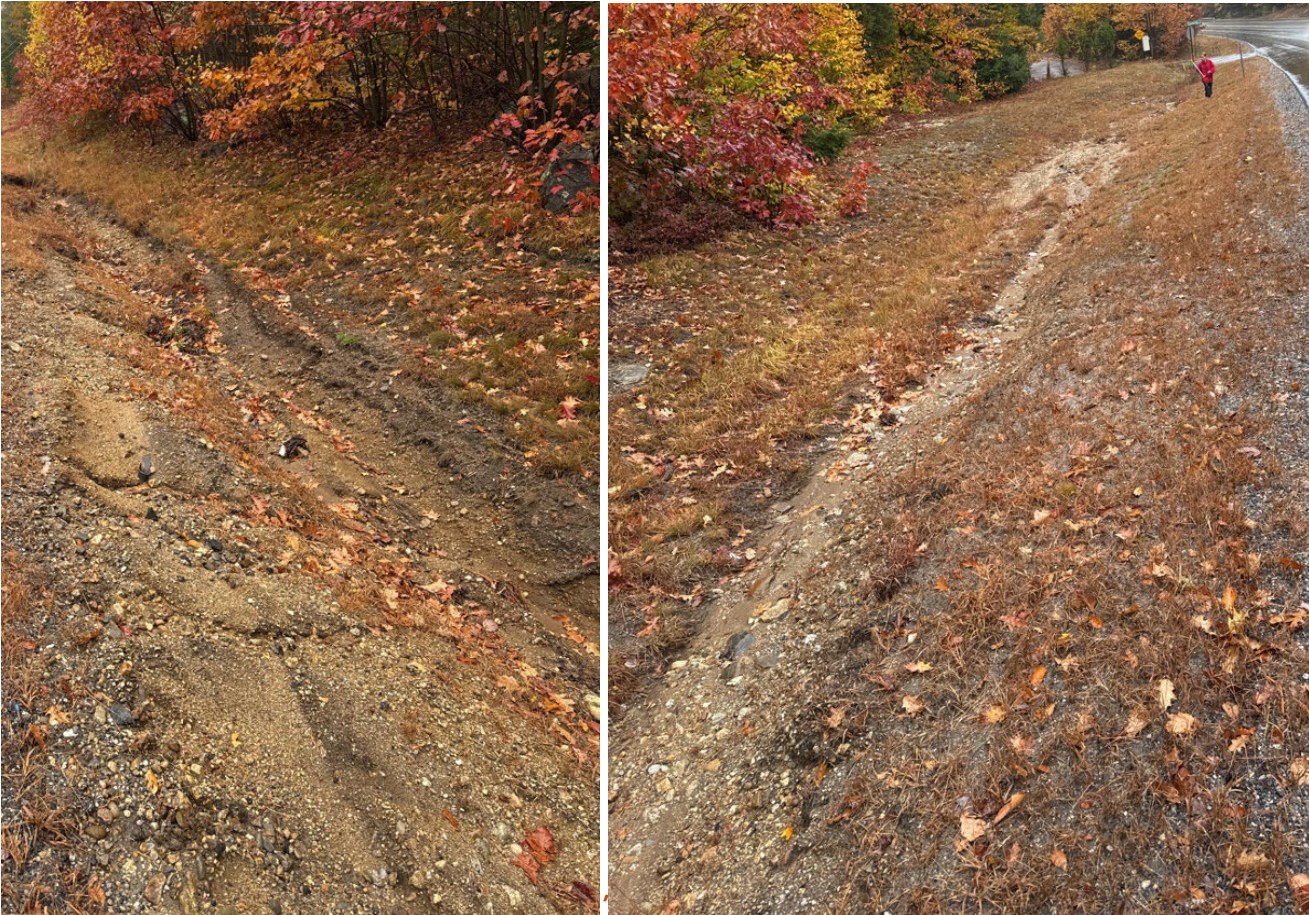
## Site B-11: Route 119

**Observations:** Large gully runs next to New Hampshire Route 119, flanked by a road shoulder consisting of a large and poorly vegetated slope. The gully travels down-hill to a catch basin, which outlets near a stream.

*Large erosion gully alongside New Hampshire Route 119. Gully leads to catch basin at the bottom of the hill (right) with a stream down the hill.*

**Recommendations:** Install riprap and vegetate the gully with salt-tolerant plant species. Road salt can inhibit or kill typical grasses, which may explain the lack of vegetation at this location. Add an infiltration basin before the water reaches the catch basin.
