# Lake Monomonac | Watershed Survey Results

**TO:** Don Wilson and Midge Romanow, MLPOA  
**FROM:** Grace Little, FB Environmental Associates (FBE)  
**SUBJECT:** Lake Monomonac Watershed Survey Results  
**DATE:** February 20, 2026  
**CC:** Laura Diemer, Tim Kirsten, & Amelia Wallis, FB Environmental Associates

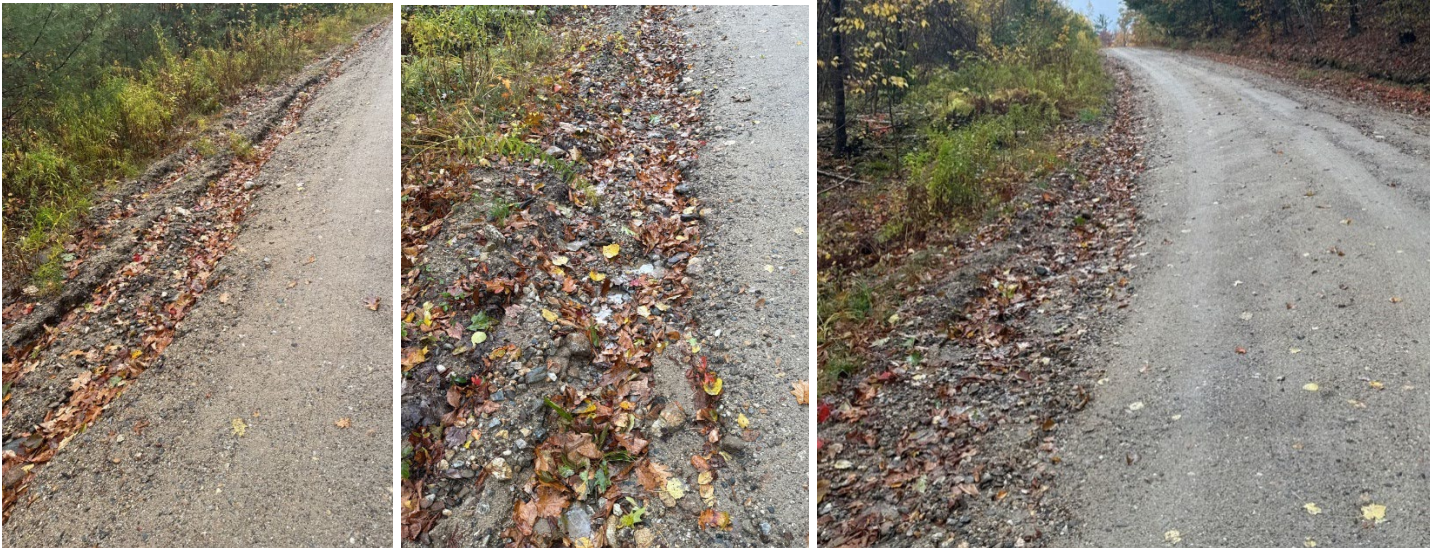
## Site B-12: Lord Hill Road

**Observations:** A moderately large gully runs along the entirety of the hill down the dirt road of Lord Way. There is no established road ditch on this side of the road, so the water runs on the road instead. While multiple turnouts are present upstream, they are slightly clogged and poorly pitched so the water does not flow into them. Additional gullies are located on other portions of the road. The majority of the stormwater outlets into the woods at the bottom of the hill attenuating sediment transport, though stormwater under high flow likely reaches the stream. Lord Hill Road is a town owned road of Rindge, NH.

Large erosion gully running on the side of the road located on the road and not in an established road ditch (left and middle). Smaller gullies running down other parts of the road (right).

**Recommendations:** Re-dig turnouts so the water flows into them rather than down the hill and add sandbags to help control flow direction. Install an established plunge pool or infiltration basin at the bottom of the hill.

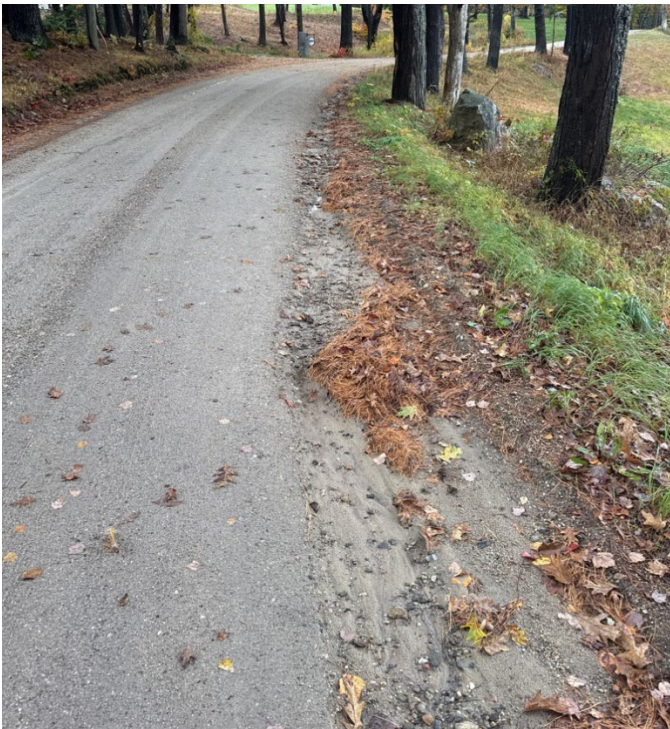
## Site B-13: Goddard Road

**Observations:** A long, narrow gully runs along a substantial stretch of Goddard Road before discharging into a grass area that slopes down to Little Crowcroft Pond, a small waterbody that drains to Lake Monomonic. Sediment transport is visible along the entirety of the gully and at the outlet where sediment overlays grass. During high-flow conditions, stormwater from Goddard Road is likely carried directly into Little Crowcroft Pond, flowing over the mowed section between the road and waterbody. Goddard Road is a town owned road of Rindge, NH.

*The erosion gully running alongside Goddard Road, with Lake Monomonic to the right. Sediment transport is visible in the gully, and the mowed area between the gully and pond is visible.*

**Recommendations:** Improve the vegetated buffer between the road and Little Crowcroft Pond, which is primarily grass and a few trees. Consider establishing a plunge pool or infiltration basin at the bottom of the hill before the water reaches the pond.

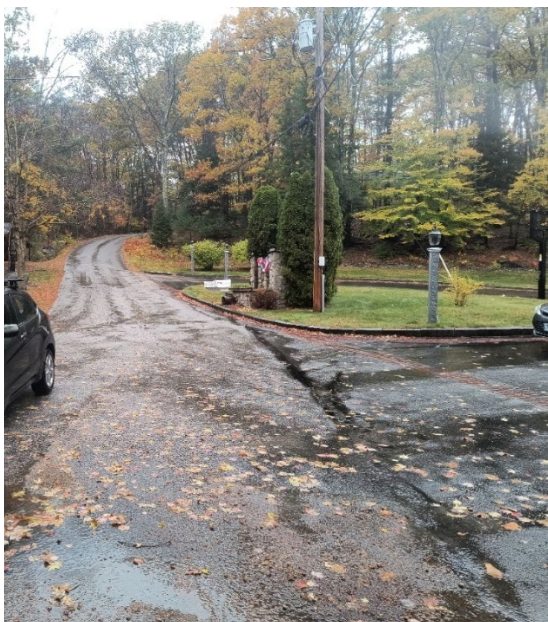
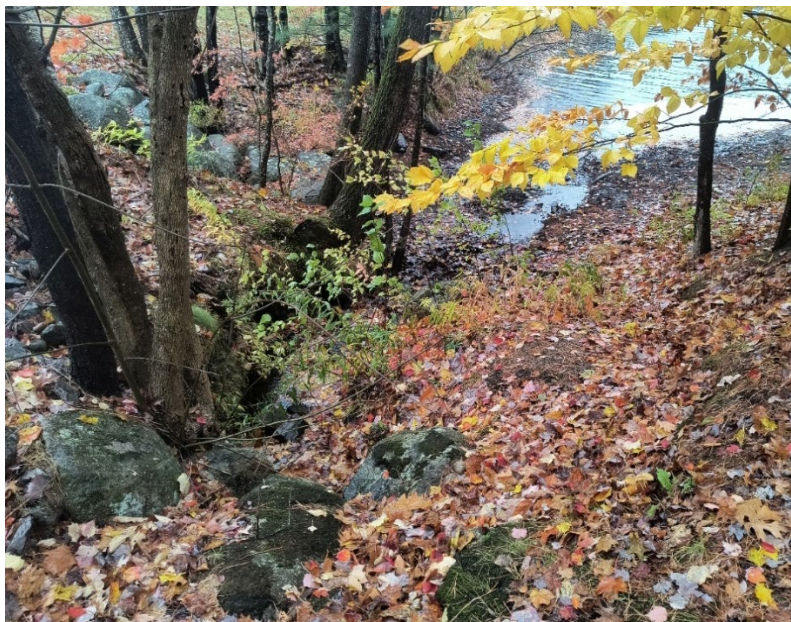
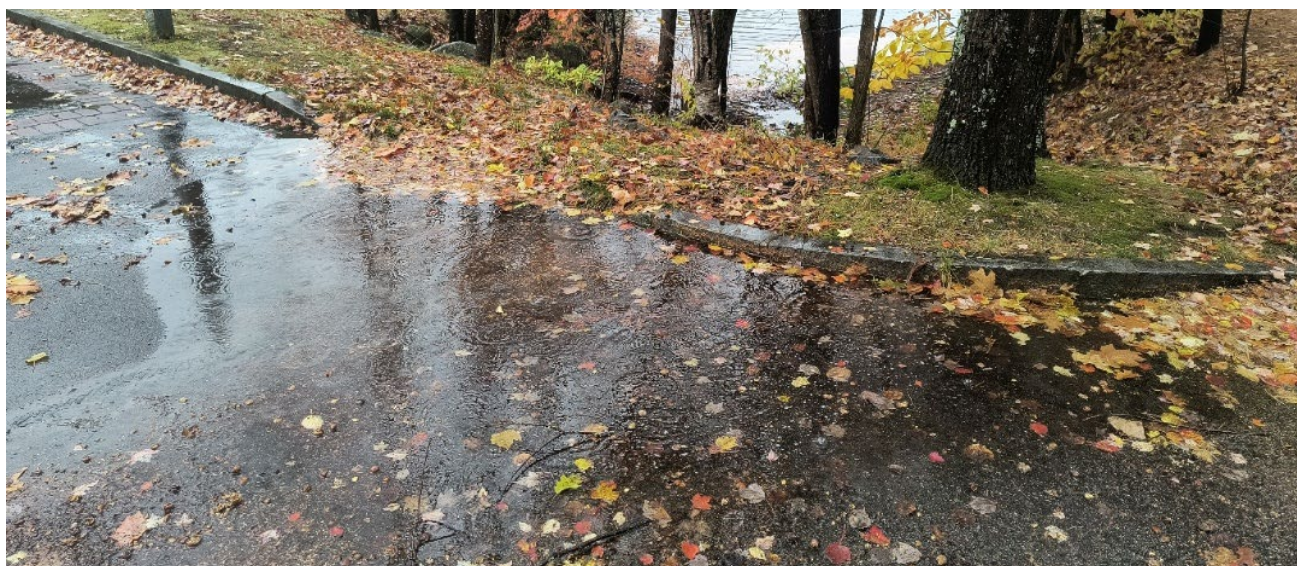
#### Site DPW-4: Coot Bay Drive

**Observations:** Coot Bay on the west side of Lake Monomonac has elevated chloride levels from road salt. Coot Bay Drive is a very steep road leading from Wellington Road to the lake. It is a residential road with relatively low traffic and deicing salt applied in the winter. Rindge DPW has calibrated its sand and salt mixture for all roads in the Town based on road length, width, and slope in contrast to the salt-only mix NHDOT applies to Routes 109 and 202 (according to the DPW Director). The portion of the road closest to the lake is privately owned, which limits the Town's ability to install stormwater runoff treatment measures and ensure well calibrated salt application along this critical lakeside section of the road. Because the road is steep and largely impervious, it is a priority concern area, as sand, sediment, and road salt are readily washed downhill toward the lake.

*Looking up Coot Bay Drive, where runoff (with high road salt concentrations in winter) flows down the road surface (top left). Water pools in a low point in the road (bottom) before flowing to the lake through a small, steep wooded area with limited ground cover and minimal pollutant attenuation (bottom and top right).*

**Recommendations:** Contact private property owners at the end of Coot Bay Road and work with them to identify options to treat stormwater and reduce chloride pollution to the lake. Opportunities may include enhancing shoreline buffers or installing compact stormwater control measures. Additionally, coordinate with NHDOT and MassDOT to review their road salting practices in the watershed and ensure they align with their respective states' guidance. The Town of Rindge should also evaluate how salt and sand are applied at the top of the hill on Coot Bay Road, as materials readily travel downslope, and adjust downward where feasible the application rates and timing while still maintaining winter road safety. Consider having Town of Rindge staff participate [Green SnowPro](#) training, which educates and certifies winter maintenance professionals in salt reduction practices which improve water quality while protecting public safety.

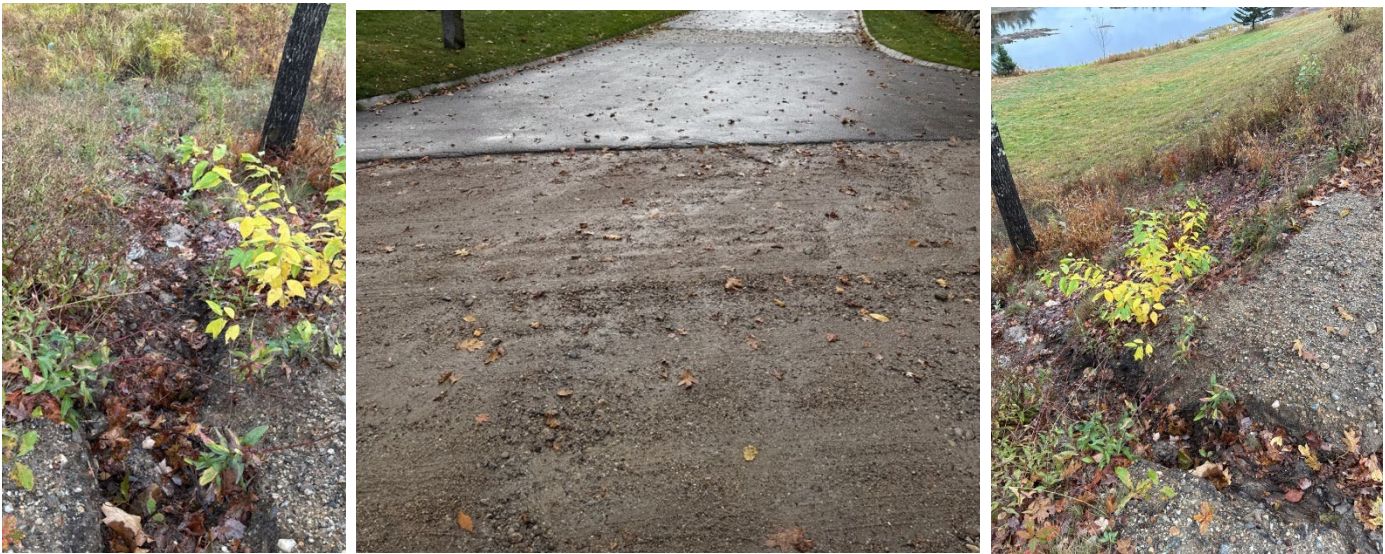
## Site B-14: Goddard Road Private Driveway

**Observations:** A deep gully has formed downstream of a large, paved driveway on a property with a lush green lawn and lots of impervious surface. The gully has deeply eroded part of the road shoulder and leads into a grassy area towards Little Crowcroft Pond which is a small waterbody that drains to Lake Monomonic. This gully is directly in-line with the paved driveway and is the only gully of its type in the area.

*Deep erosion gully that flows into a grassed area along the shoreline of Little Crowcroft Pond (left). A portion of the large, sloped driveway which channels stormwater directly into the road (middle). The proximity of the gully to Little Crowcroft Pond, and the minimal vegetation between the two (right).*

**Recommendations:** Conduct outreach and education to property owners on driveway best management practices. Add a plunge pool to the base of the gully before the water reaches Little Crowcroft Pond, and enhance the buffer in this area. Consider working with the property owner to re-pitch the driveway to re-direct stormwater into a catch basin uphill of the dirt road, combined with a plunge pool or settling basin at the outlet before reaching the lake.

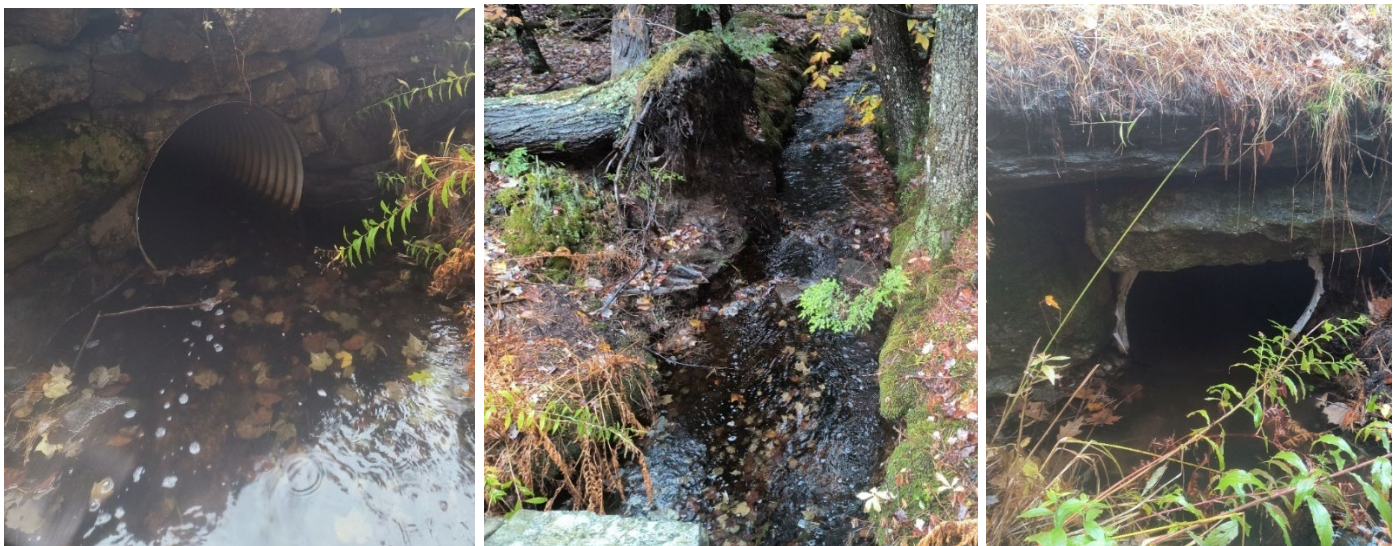
### Site DPW-1: East Monomanac Road Culverts

**Observations:** There are several culverts beneath East Monomanac Road, including the one described in Site M-6. Most of these are two feet in diameter, which appears well-sized for their sub-watersheds. They are generally made of plastic or corrugated steel, but none are concrete. Many have a stone headwall. Headwalls appeared in good condition although at least one culvert appears partially crushed (see photos). Rindge DPW has placed crushed stone at culverts where siltation and erosion were occurring. Debris is cleaned out as needed. Most of the culverts drain to meandering streams in forested land between the road and the lake.

*One of the 2-foot corrugated steel culverts with a stone headwall beneath East Monomanac Road (left). One of the streams at the outlet of a culvert on this road, flowing through a forested area (middle). A partially crushed plastic culvert with a stone headwall on the same road (right).*

**Recommendations:** Continue regular observation and maintenance of culverts, including clearing debris and placing crushed stone when scour occurs. Assess whether partially crushed culverts should be replaced or rehabilitated.

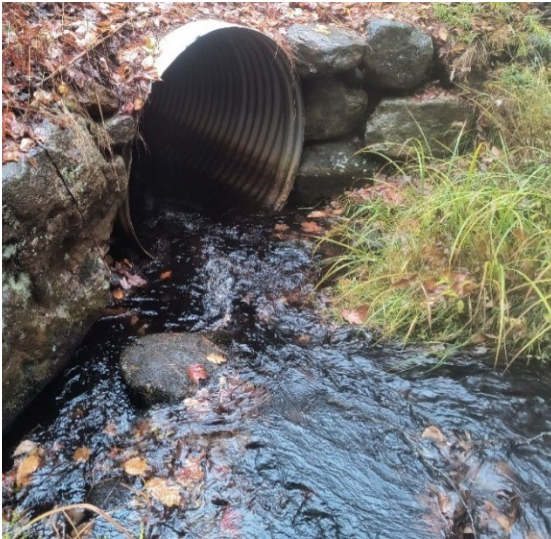
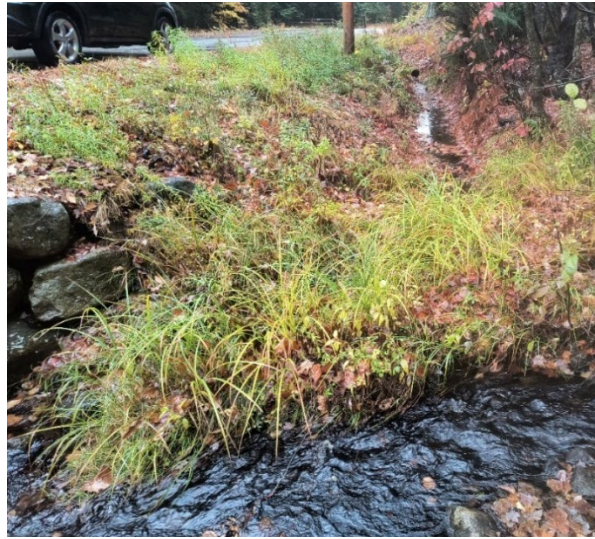
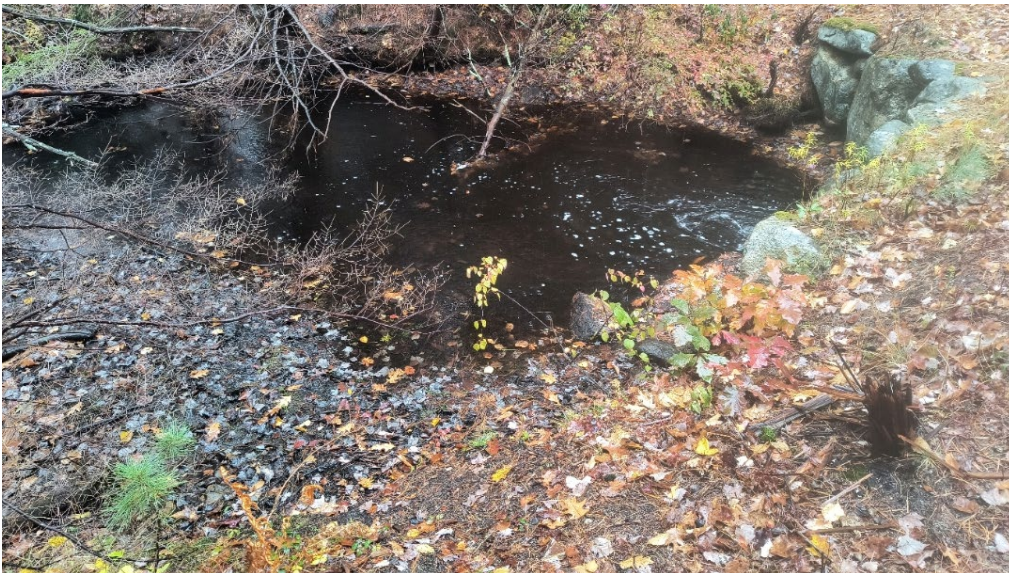
### Site DPW-3: Swan Point Road Culvert

**Observations:** A large culvert conveys a perennial stream from north of Lake Monomonac to a cove near Swan Point, crossing beneath Swan Point Road. Stormwater runoff from a ditch on the north side of Swan Point Road also discharges to this culvert inlet. The culvert appears well-sized to handle large storm events and the stone headwall is stable, although some bank undercutting was observed at the outlet. Some riprap has been installed to stabilize the banks around the culvert. The stream bank and the end of the roadside ditch is well vegetated with wetland plants, providing a good buffer to treat stormwater runoff. However, there is limited ground cover in the road shoulder on the outlet side.

*A view of the culvert inlet, a corrugated metal pipe with a stone headwall (top left). The roadside ditch with an herbaceous buffer before draining to the stream (top right). The downstream side of the culvert, which has limited vegetation along the road shoulder and some bank scour at the outlet (bottom).*

**Recommendations:** While this culvert is generally good, the scour at the outlet could become an NPS concern in the future. We recommend planting live stakes of shoreline species such as native willows, dogwoods, elderberries, and buttonbush. These are generally more cost-effective than container plantings and can be harvested from species already growing on site. Planting these in the spring is ideal, although late fall is also an option. These plantings would supplement the riprap already in place and further stabilize the site, in addition to providing benefits to wildlife. We also recommend seeding the shoulder above the outlet with native herb species to treat runoff that enters the stream from this side of the road.
