# Lake Monomonac | Watershed Survey Results

**TO:** Don Wilson and Midge Romanow, MLPOA  
**FROM:** Grace Little, FB Environmental Associates (FBE)  
**SUBJECT:** Lake Monomonac Watershed Survey Results  
**DATE:** February 20, 2026  
**CC:** Laura Diemer, Tim Kirsten, & Amelia Wallis, FB Environmental Associates

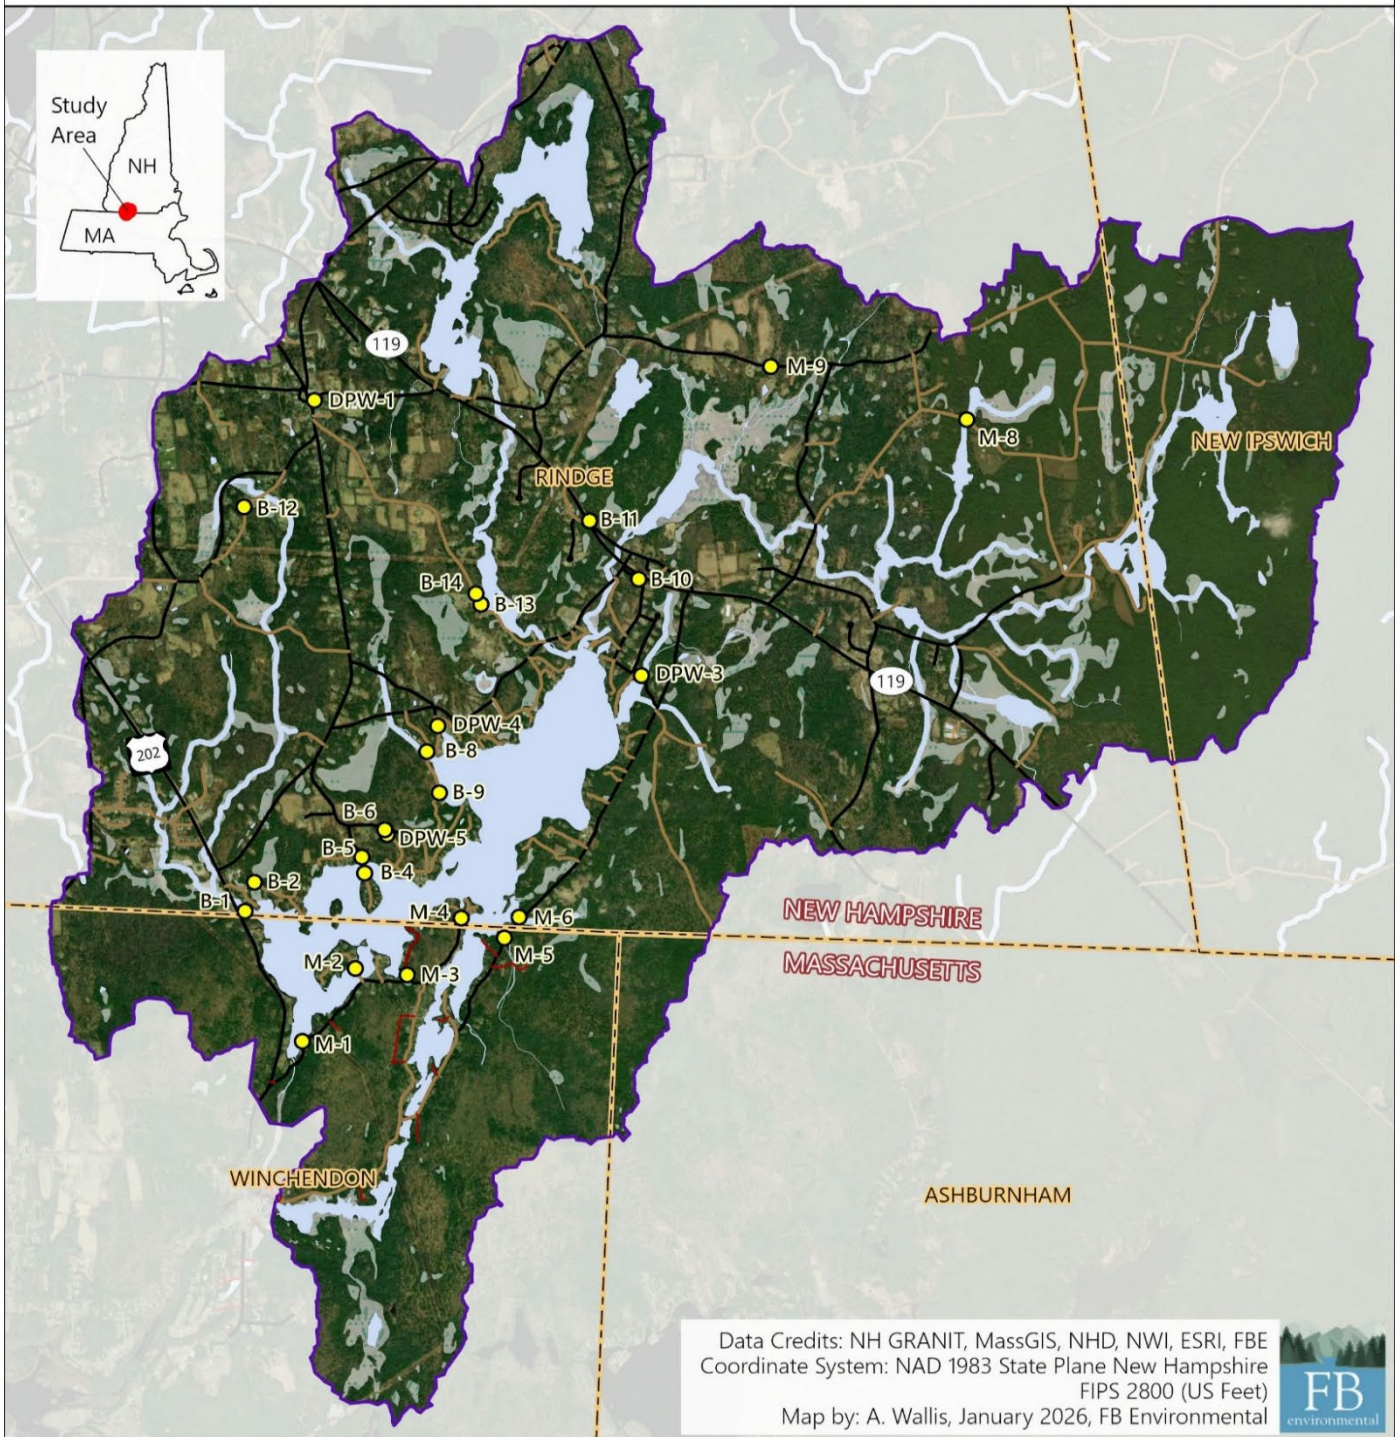
**Figure 1.** Location of identified nonpoint source sites in the Lake Monomonic watershed.

FB Environmental Associates (FBE) was contracted by the Monomonac Lake Property Owners Association (MLPOA) with funding from the NHDES Watershed Assistance Section to complete a watershed survey that identifies and documents nonpoint source (NPS) sites in the Lake Monomonac watershed in Rindge and New Ipswich, NH and Winchendon, MA. NPS sites require implementation of best management practices (BMPs) due to impacts from stormwater, erosion, lack of infiltration (impervious cover), culvert restrictions, and/or lack of vegetated riparian buffer. On October 20<sup>th</sup>, 2025, technical staff from FBE (Grace Little, Tim Kirsten, Sierra Guite, and Amelia Wallis) along with Rindge Director of Public Works (Michael Sr. Cloutier) surveyed the watershed. It rained from 6:30 am to 12:30 pm that morning, for a total of 0.86 inches of rainfall in the area. Documentation included describing the problem, making recommendations for fixing the problem, rating the site's impact to water quality, logging the site's location via GPS, and taking photographs. A total of 20 NPS sites were documented during the survey, with the addition of four sites of interest (Figure 1).
